**BLACKSTONE RIVER BASIN
HOLDEN, MASSACHUSETTS**

**HOLDEN RESERVOIR NO. 2 DAM
MA 00619**

**PHASE I INSPECTION REPORT
NATIONAL DAM INSPECTION PROGRAM**

OCTOBER 1978

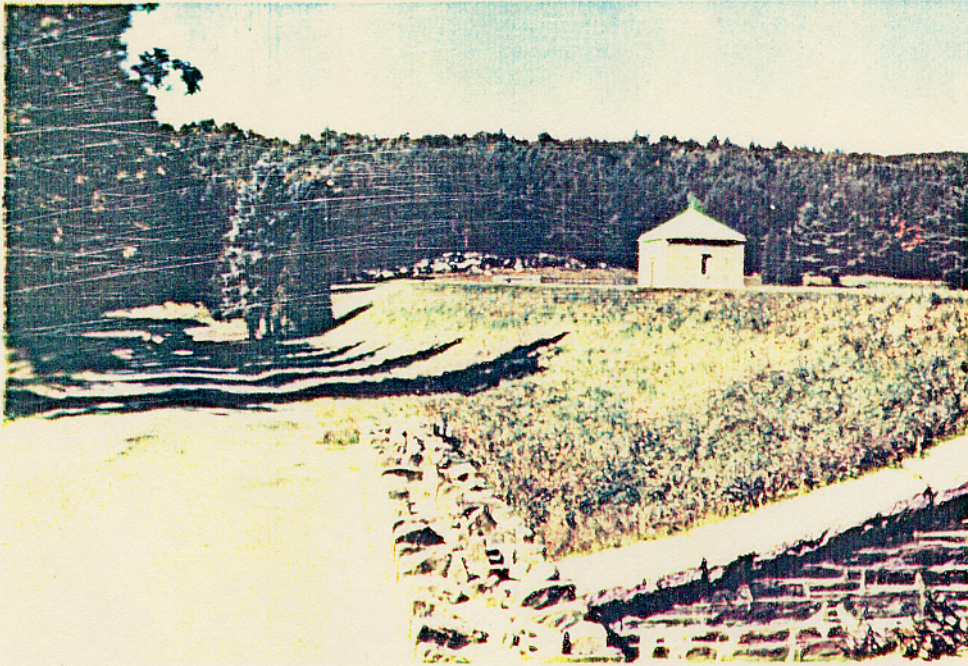
- b. Dam. The earth embankment of the dam is in generally good condition. The crest and downstream slope are clear of brush and trees. Numerous animal burrows were observed at the downstream toe of the dam, in the spoil bank area. The grouted riprap on the upstream slope is in fair condition. Some of the riprap is missing and there are weeds growing through cracks in the grout. The condition of the riprap is poorest in the vicinity on the service bridge to the gate house. Here, settlement and slumping of the slope is evident by the large cracks in the grout, parallel to the axis of the dam.

NO. 1 DOWNSTREAM FACE OF DAM

- a. Operating and Maintenance Procedures. The grounds and embankment of the dam are well maintained. However, it is recommended that the Owner add the following items to the maintenance program:
 - (1) repair the stone masonry side walls to the spillway, and resurface the floor of the channel
 - (2) repair the stone work on the bridge spanning the spillway
 - (3) repair or replace the granite weir on the spillway
 - (4) clear the accumulated soil and rock from the stilling basin
 - (5) fill in the animal burrows on the downstream face of the dam
 - (6) clear the bushes and weeds from the downstream channel

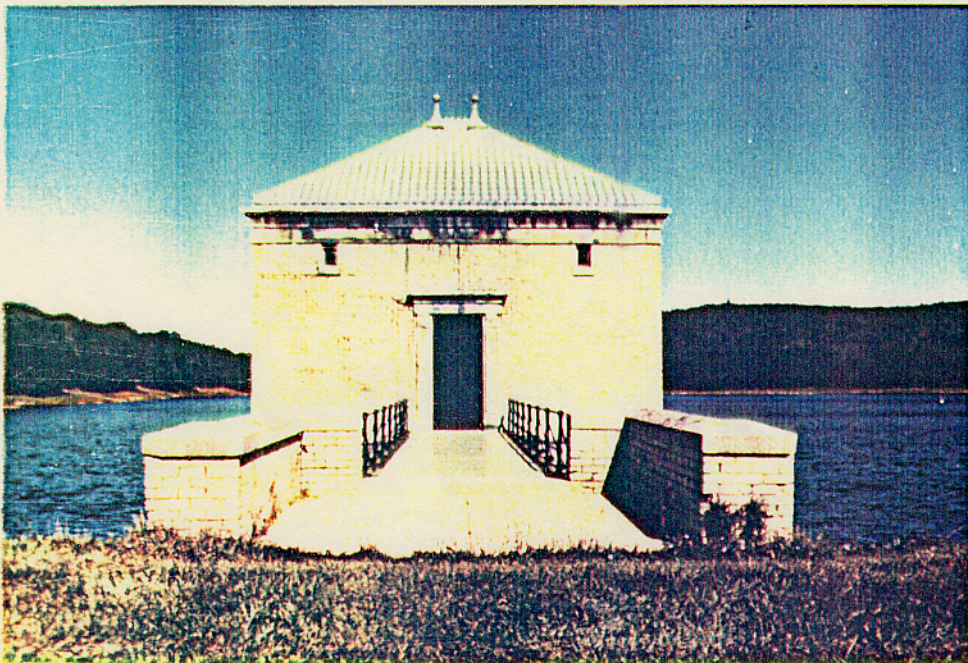
The gate house in the reservoir is in good condition, with only minor cracking in the brick work. The three hand-operated sluice gates are reportedly in good operating condition. The screened intake is kept clear at all times.

NO. 2 GATE HOUSE

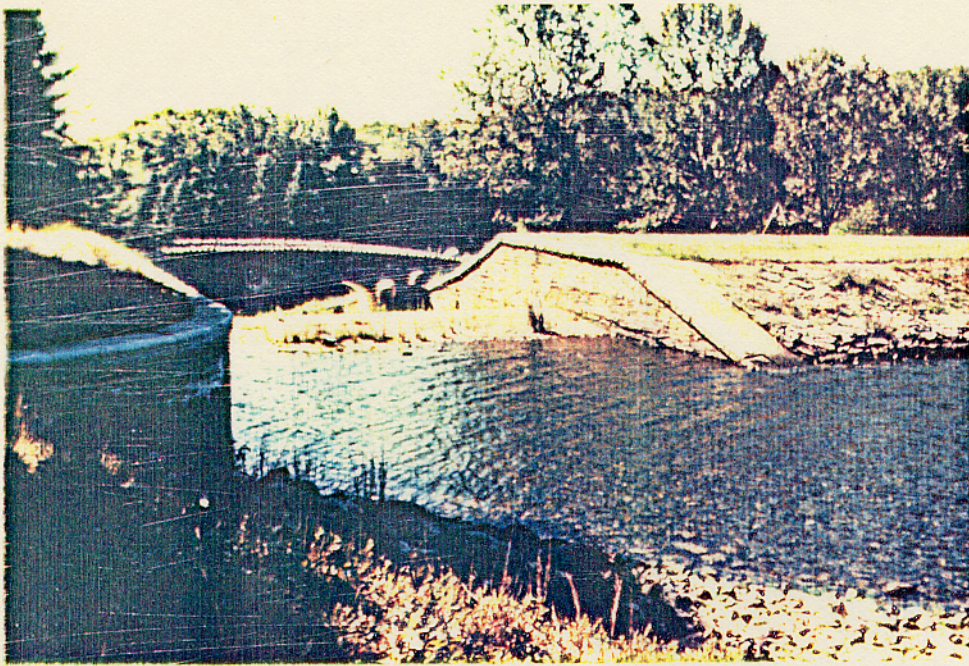
- c. Appurtenant Structures. The spillway is in good to fair condition. Stone walls in the approach and downstream channel show a significant amount of efflorescence. Some mortar is missing between the stones. The floor of the approach channel has some weeds growing up through cracks in the mortar. The concrete slabs on the floor of the channel are in fair condition. Some of the slabs are cracked. Weeds are generally growing in the construction joints and at the base of the sidewalls.

NO. 3 UPSTREAM VIEW OF SPILLWAY, FROM
LEFT ABUTMENT

- a. to conduct a more detailed hydrologic and hydraulic investigation at the site;
- b. to design repairs for the spillway and training walls.

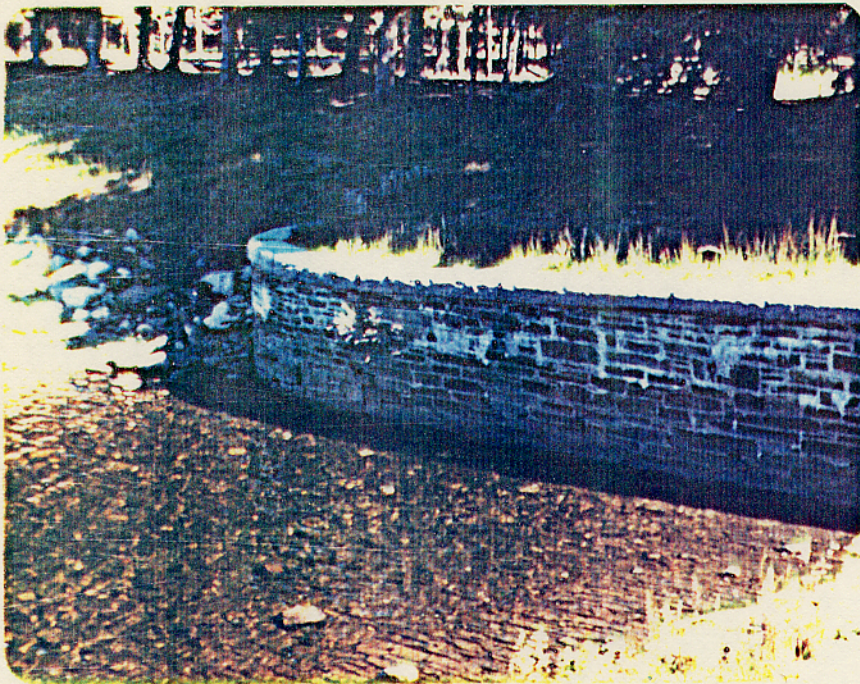
b. Weir and Training Walls	efflorescence, loose stone and mortar on walls granite ogée weir with concrete patch
General Condition of Concrete	concrete patch on weir is loose
Rust or Staining	rust from flashboard pins
Spalling	patch on weir is spalled
Any Visible Reinforcing	none
Any Seepage or Efflorescence	significant efflorescence
Drain Holes	none

NO. 4 LEFT WING WALL OF SPILLWAY

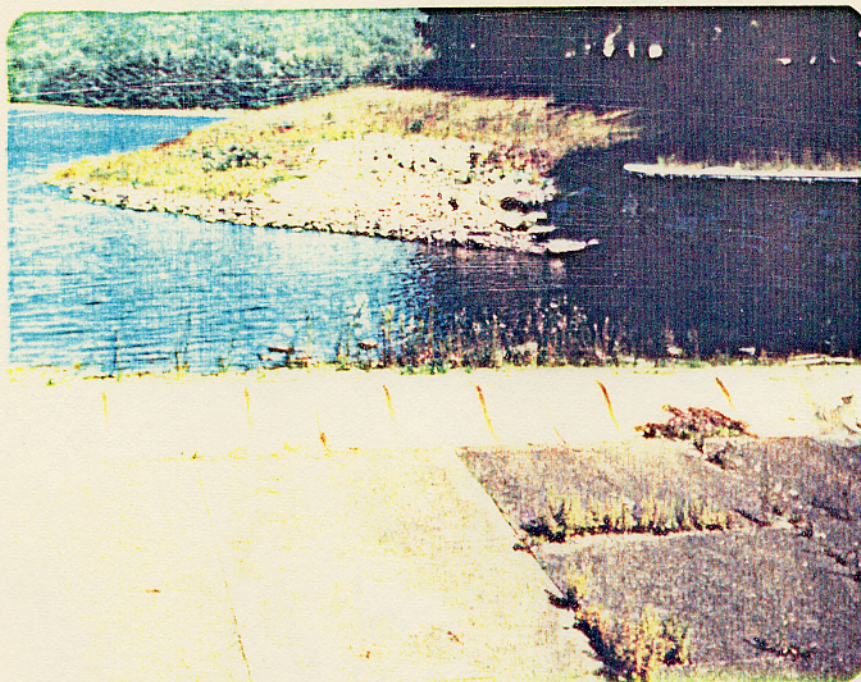
The granite ogee weir is showing signs of deterioration. One section of the weir has been patched with mortar that is beginning

to spall. Elsewhere the granite has been chipped at the crest. The weir is stained with rust from the flashboard pins.

NO. 5 GRANITE WEIR AND FLOOR OF SPILLWAY

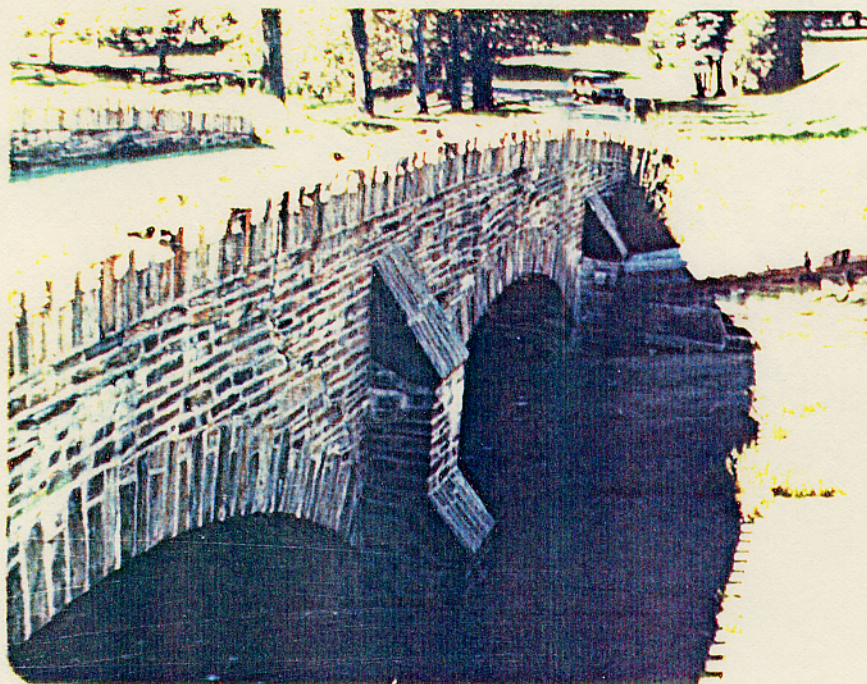
The bridge over the spillway shows heavy efflorescence, particularly under the archways. The mortar is crumbling between the stones and often missing altogether in some places. Settlement of the central pier is evident by the diagonal cracks appearing on the upstream face of the bridge and by other cracks in the concrete floor around the pier. There is another large crack in the mortar on the downstream face of the bridge, at the right spillway wall. The decorative capwall on the bridge has been displaced on the upstream side. An entire section of this wall was knocked off the downstream side by a vehicle. Pieces of the wall are still lying on the floor of the downstream channel. There are areas of erosion on the earth slopes at the bridge abutments.

- d. Bridge over discharge channel - double arch masonry bridge
diagonal shear cracks at abutment
settlement at center pier
heavy efflorescence under bridge ; mortar missing
capwall. u/s - displaced
d/s - partially missing
- e. spillway channel - descends to stilling pool
accumulation of dirt and stone in pool
cascade step weir from stilling pool
* 30-inch pipe d/s of cascade stilling pool, right side
loose stones in lower channel
grouted stone wall for 70 feet
Changes to natural channel except on right
side which is stone masonry wall
Trees overhanging lower channel.
- * 6-inch cast-iron pipe in stilling pool cascade face.

NO. 6 BRIDGE OVER SPILLWAY CHANNEL;
VIEW TOWARD RIGHT ABUTMENT

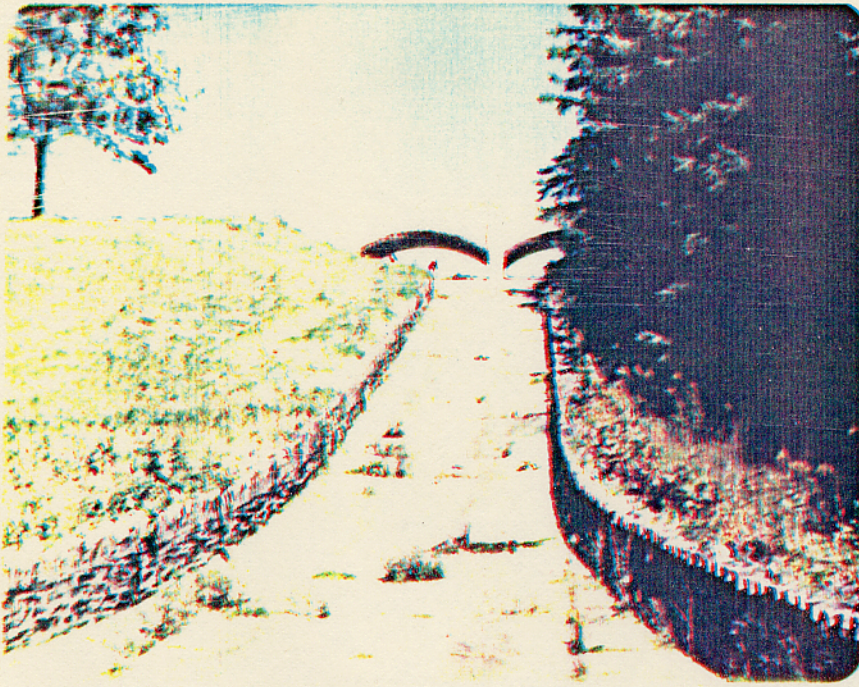
c. Discharge Channel	concrete slabs
General Condition	good to poor - some cracking, weeds erosion from roadway at d/s left abut.
Loose Rock Overhanging Channel	none
Trees Overhanging Channel	none
Floor of Channel	cracks, few pieces of slab missing
Other Obstructions	none

NO. 7 DOWNSTREAM CHANNEL OF SPILLWAY

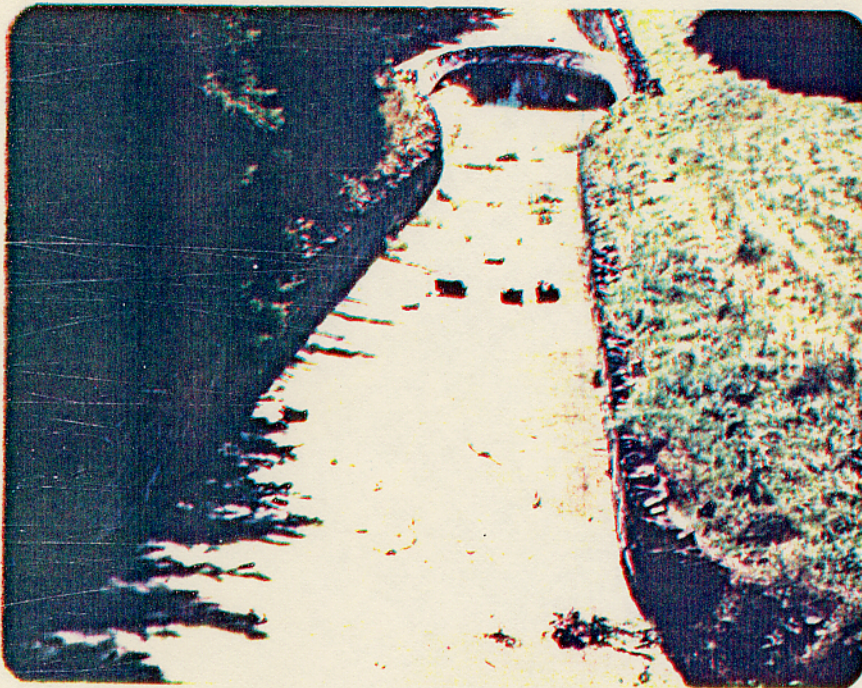
NO. 8 DOWNSTREAM CHANNEL OF SPILLWAY,
AND STILLING BASIN
